## Ecological site R022AX103CA Cryic E Meadow System

## R022AX103CA, Cryic E Meadow System

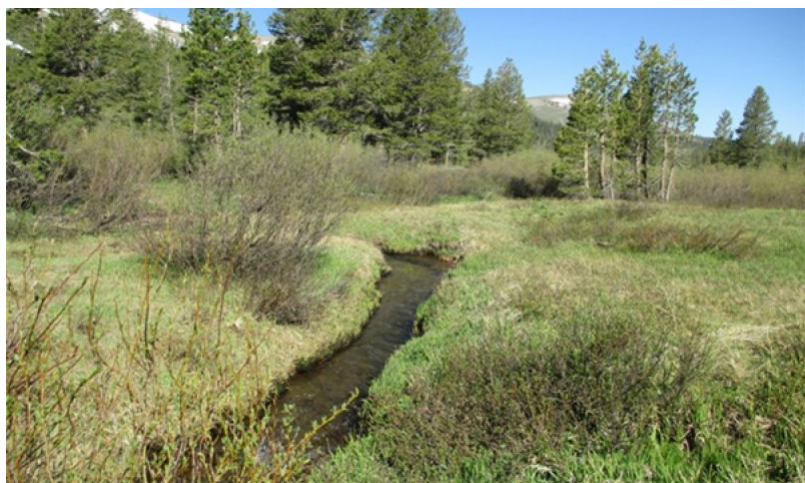
**Figure 6. E channel**

The E type channel flows through gently sloping alpine meadows. The channel is a small, stable, narrow, deep, meandering stream. These meadows maintain a high water table throughout the summer, and floods reach over the banks, two out of three years, which supports a healthy community of sedges and willows. Several community components are associated with this phase. CC1, Discharge slopes and depressions: This community typically occurs upslope of the main meadow, where subsurface flow seeps to the surface, creating a cool, perennially wet site that typically develops deep histic soil horizons. This component may also develop in depressional basins within the meadow. There are several plant communities that may occur on the discharge slopes. The variation is due in part by past disturbances, and in part by abiotic variation such as aspect. However, the scale required to capture these unique assemblages is beyond the scope of the soil survey. The most common plant communities are fen communities with high cover of mosses (*Sphagnum* and other sp.). Mountain sedge, Northwest Territory sedge (*Carex utriculata*) and spikerush (*Eleocharis* sp.) are dominant. Water sedge (*Carex aquatilis*), blister sedge (*Carex vesicaria*) and lakeshore sedge (*Carex lenticularis*) are present along small rivulets that have surface flow or ponded areas of standing water. Patches of mountain willow and Sierra willow can range from sparse to dense. Forbs typically are only a minor component and include (*Arnica mollis*), alpine shootingstar (*Dodecatheon alpinum*), Sierra shootingstar (*Dodecatheon jeffreyi*), willowherb (*Epilobium* sp.), alpine gentian (*Gentiana newberryi*), tinker's penny (*Hypericum anagalloides*), primrose monkeyflower (*Mimulus primuloides*), tundra aster (*Oreostemma alpigenum* var. *alpigenum*), Parish's yampah (*Perideridia parishii*), longleaf starwort (*Stellaria longifolia*), and western aster (*Symphyotrichum ascendens*). Meadow bistort (*Polygonum bistorta*) and California false hellebore (*Veratrum californicum*) may occasionally be dominant. CC2 Floodplain, frequently flooded: This community develops along the channel and on broad, frequently flooded floodplains. Mountain willow occurs along the stream and in the very wet areas. Sierra willow can be present or absent, and it may occur further from the stream. Other willow species may be present. In cooler or higher elevation sites western moss heather (*Cassiope mertensiana*), purple mountainheath (*Phyllodoce breweri*) and rose meadowsweet (*Spiraea splendens* var. *splendens*) are present. Mountain sedge is the dominant understory sedge, with bentgrass (*Agrostis* sp.), lakeshore sedge, Northwest Territory sedge, tufted hairgrass, slender hairgrass (*Deschampsia elongata*), pullup muhly (*Muhlenbergia filiformis*) and Donner woodrush (*Luzula subcongesta*) are often present. Forb diversity is relatively high. Common forbs include Pacific onion (*Allium validum*), alpine gentian, tinker's penny, bigleaf lupine (*Lupinus polyphyllus*),

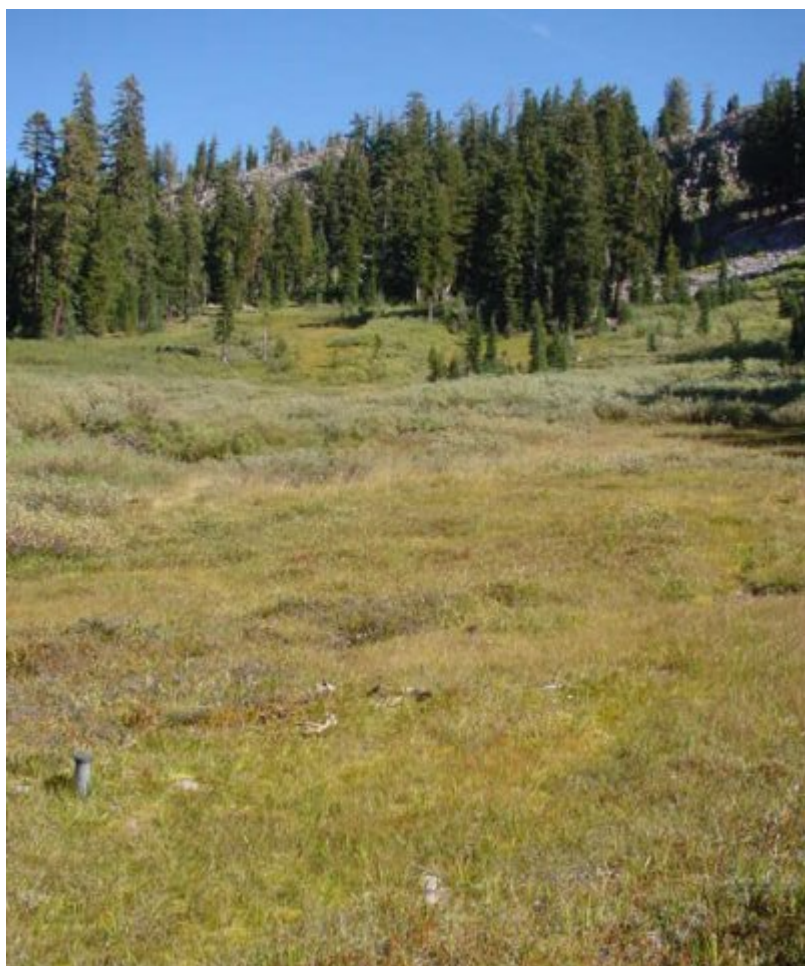
**Figure 7. CT1 Discharge Slope**

The Hellhole soil occurs in areas with permanent high water tables, which allows deep organic soils to develop from moss fibers. The hellhole soils are Euic, frigid Typic Sphagnofibrists. They are rarely flooded for brief durations, but are frequently ponded (saturated) for long durations. Available water capacity is 21.7 to 25.6 inches in the upper 40 inches of soil (ESIS does not allow AWC greater than 15.99 to be entered). CC1 and CC2 are associated with this component.

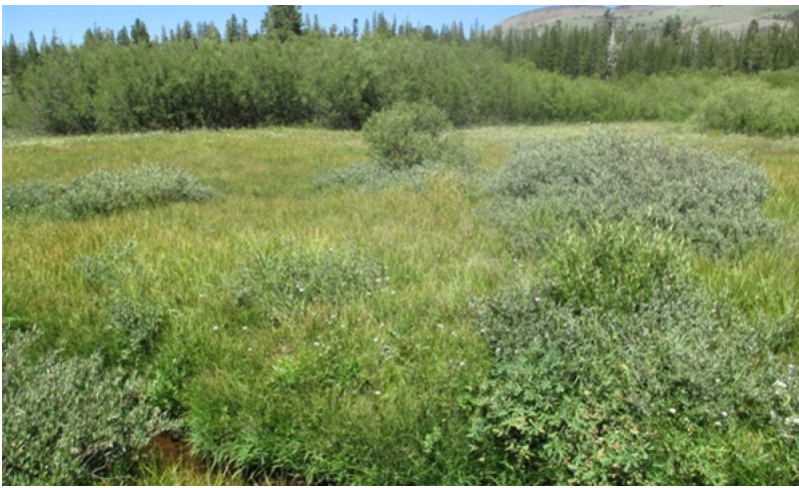
Figure 8. CT2 Floodplains

The Bidart, wet phase occurs on the active floodplains. The Bidart soils have a mucky silt loam surface texture, with silt loam, extremely gravelly coarse sand, fine sandy loam, and sandy loam subsurface textures. These soils exhibit episodic depositional layers. Mottling from water saturation is evident at 3 inches, with gleyed conditions starting at 17 inches. The Bidart soils are coarse-loamy, mixed, superactive, acid Fluvaquentic Cryaquepts. The Bidart wet phase is frequently flooded and ponded for long durations. CC3 is associated with this component.

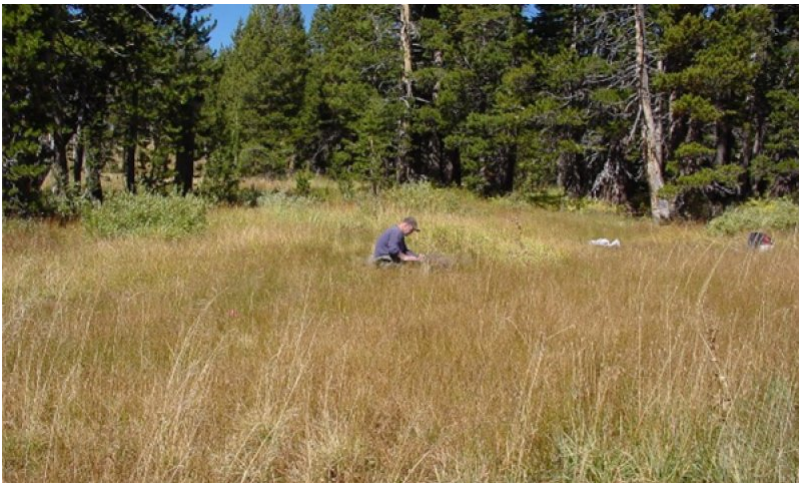
Figure 9. CT3 Floodplain Step

The Bidart silt loam component has the same features as describe for the Bidart wet phase, but it is occasionally flooded and ponded, due to its higher topographic position on the floodplain. CC4 is associated with this component.

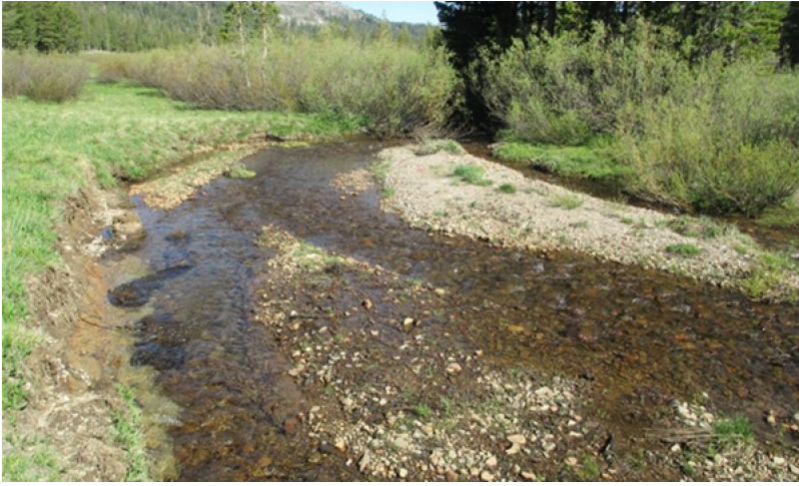
**Figure 11. F Channel**

The F type channel is wide, shallow and incised, with unstable actively eroding banks. Community components and community composition is similar as described in the G type channel phase. The wider channel and lack of vegetation on the banks, causes an exposed channel with little shade across the stream. Silt and sand from actively eroding banks causes a decline in habitat quality for fish and aquatic insects.

This pathway develops as bank erosion continues to widen the channel forming an F type channel.

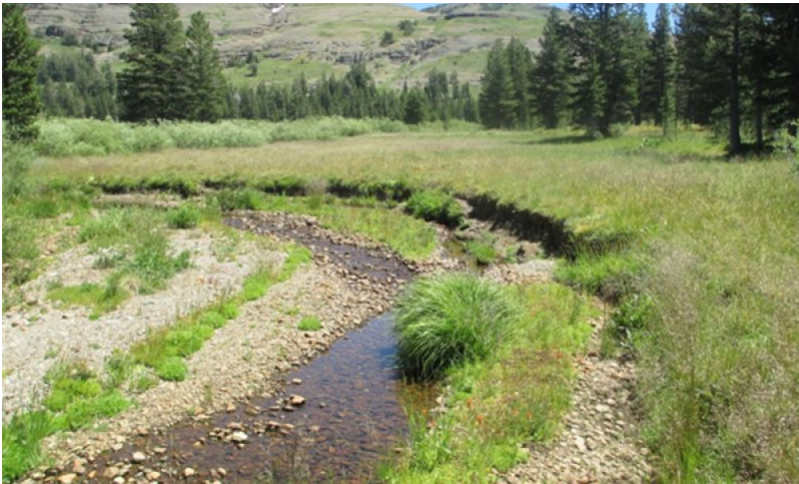
**Figure 12. F Channel to C channel**

Only the initial stages of an entrenched C channel were observed. Point bars and lower floodplains have developed in some areas within F type channels. As the floodplains develop, there will be a new narrow floodplain that can support the water table dependent species in CC1 and CC2. However, these communities will be present at a much lower extent than prior to channel incision. CC2b and CC3b will remain on the upper abandoned floodplains.

This transition occurs when the F channel has widened sufficiently to allow for a C channel type to develop with a lower, re-established floodplain.
