Ecological site R022AX105CA Steep Mountain Drainageways

R022AX105CA, Steep Mountain Drainageway Complex

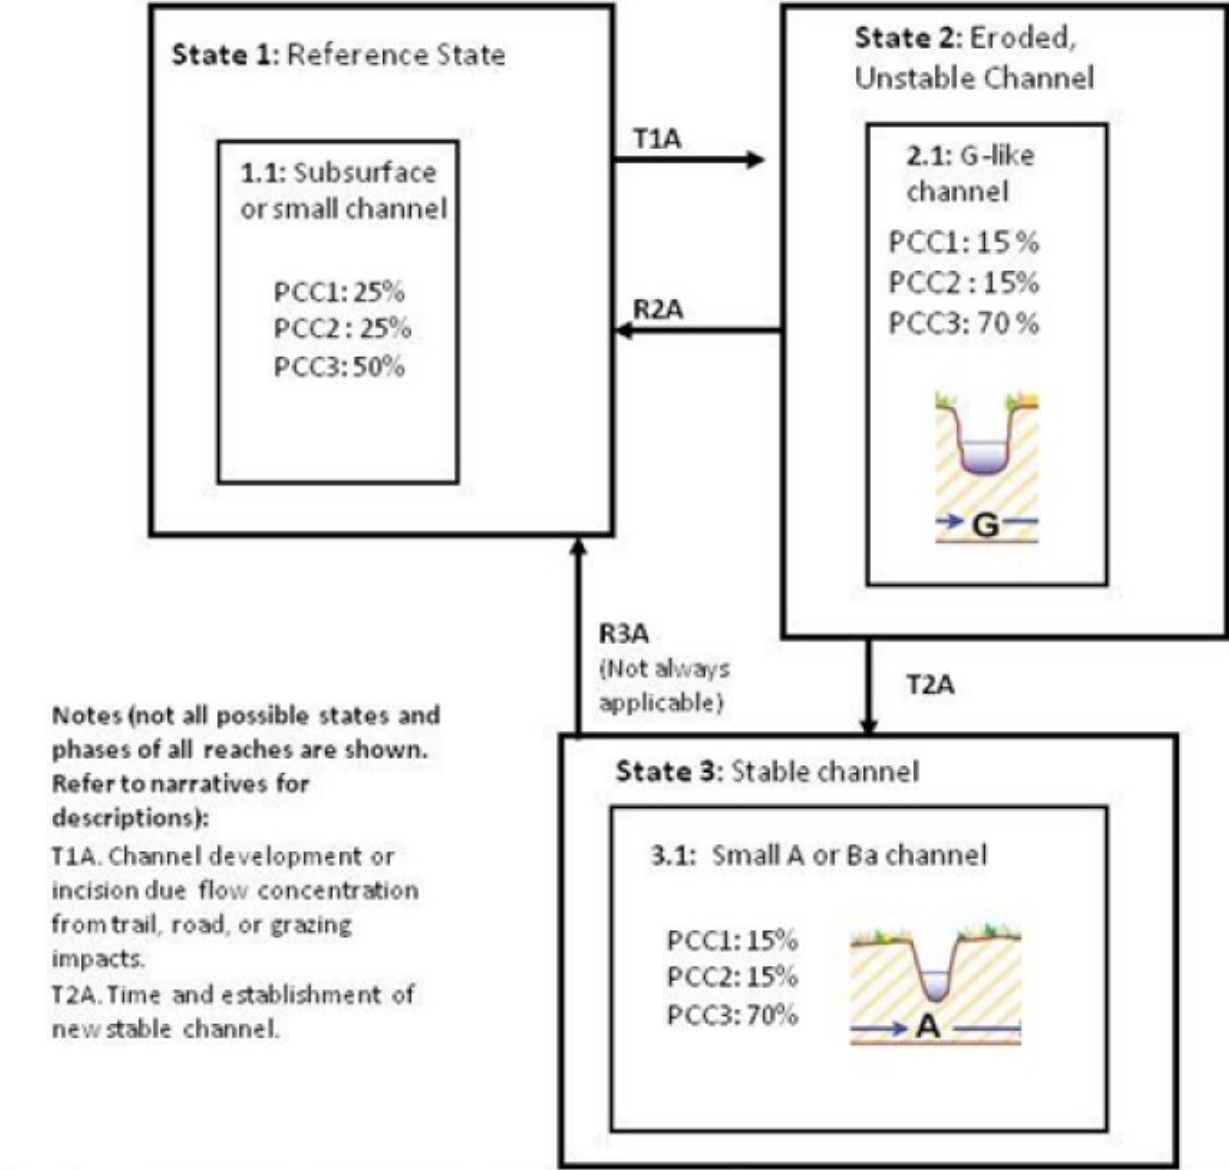
Figure 6. R022AX105CA STM

I.D.	Plant Association	Fluvial Surface/Landform
1	Thinleaf alder-Lemmon's willow	Drainageway
2	Lemmon's willow and sedges	Floodplain
3	Quaking aspen	Drainageway, margins

Transition 1.1a State 1 to 2

Restoration pathway 2.1a State 2 to 1

Transition 2.1a State 2 to 3

Restoration pathway 3.1A

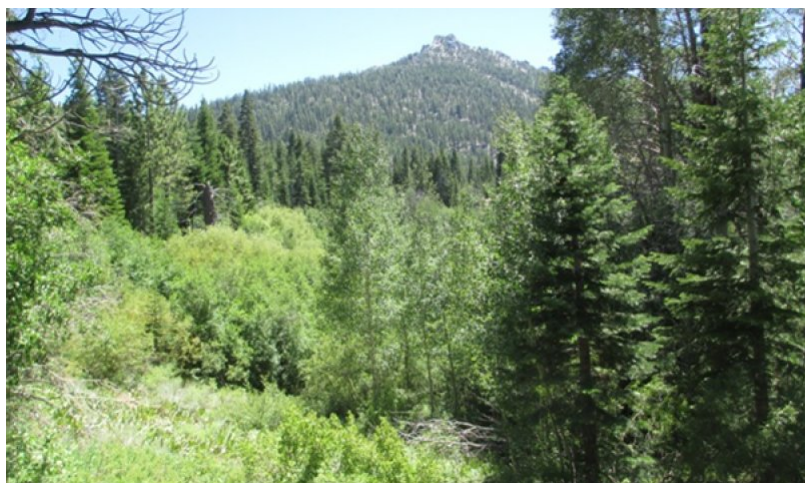
Figure 7. Area view

This phase does not have a defined channel. There may be small rivulets, or signs of surface flow through sedges or moss. This phase occurs at headwater seeps, or where slopes break from steeper drainage slopes, and flow goes subsurface. This phase has several community components that do not always occur together in one location, but repeat along the length of the stream. CC1, Drainageway This community occurs in the steeper, more confined seeps and springs. It is dominated by thinleaf alder and Lemmon's willow. Thinleaf alder prefers flowing water, and although there may not be a surface channel, the steeper slopes and sandy soils, allow for rapid subsurface flow. Thinleaf alder often occurs on areas subject to flooding and high disturbances, however these areas are relatively stable. Thinleaf alder fixes nitrogen, captures fine sediments in its roots during spring sheep flows, and produces copious amounts of leaf litter. These attributes help develop a nutrient rich soil surface. Lemmon's willow is more tolerant to prolonged saturation and will occur in areas with lower slopes, or finer soil textures. Common species in this community component are Columbian monkshood (*Aconitum columbianum*), Pacific onion (*Allium validum*), western columbine (*Aquilegia formosa*), Brewer's bittercress (*Cardamine breweri*), fringed willowherb (*Epilobium ciliatum*), scarlet fritillary (*Fritillaria recurva*), bedstraw (*Galium* sp.), common cowparsnip (*Heracleum maximum*), starry false lily of the valley (*Maianthemum stellatum*), Brewer's miterwort (*Mitella breweri*), seep monkeyflower (*Mimulus guttatus*), woollyhead parsnip (*Sphenosciadium capitellatum*), and fowl mannagrass (*Glyceria striata*). CC2, Floodplain This community occurs in broader sloping meadows. Recent alluvium may be deposited over older outwash deposits. Lemmon's willow and sedges are dominant, with a diversity of associated species. Geyer willow (*Salix geyeriana*) and shining willow (*Salix lucida*) are occasionally present. Thinleaf alder occurs in patches, or along surface channels. Whitestem gooseberry (*Ribes inerme* var. *inerme*) is present under the canopy of willows, and roundleaf snowberry (*Symphoricarpos rotundifolius*) occurs on the drier meadow edges. This community is heavily dominated by grass and grass-like. Nebraska sedge (*Carex nebrascensis*) is common and often abundant. Other grass grass-like include bentgrass (*Agrostis* sp.), water sedge (*Carex aquatilis*), slenderbeak sedge (*Carex athrostachya*), other sedges (*Carex* spp.), slimstem reedgrass (*Calamagrostis stricta*), nearlyblack sedge (*Carex subnigricans*), Northwest Territory sedge (*Carex utriculata*), blister sedge (*Carex vesicaria*), tufted hairgrass (*Deschampsia cespitosa*), slender hairgrass (*Deschampsia elongata*), fowl mannagrass (*Glyceria striata*), rushes (*Juncus* spp.), straightleaf rush (*Juncus orthophyllus*), and muhly (*Muhlenbergia* sp.). In drier or more disturbed areas brome (*Bromus* sp.), meadow barley (*Hordeum brachyantherum*), squirreltail (*Elymus elymoides*), and Kentucky bluegrass (*Poa pratensis*) increase. Common forbs include common yarrow (*Achillea millefolium*), nettleleaf giant hyssop (*Agastache urticifolia*), Pacific onion, Brewer's angelica (*Angelica breweri*), fireweed

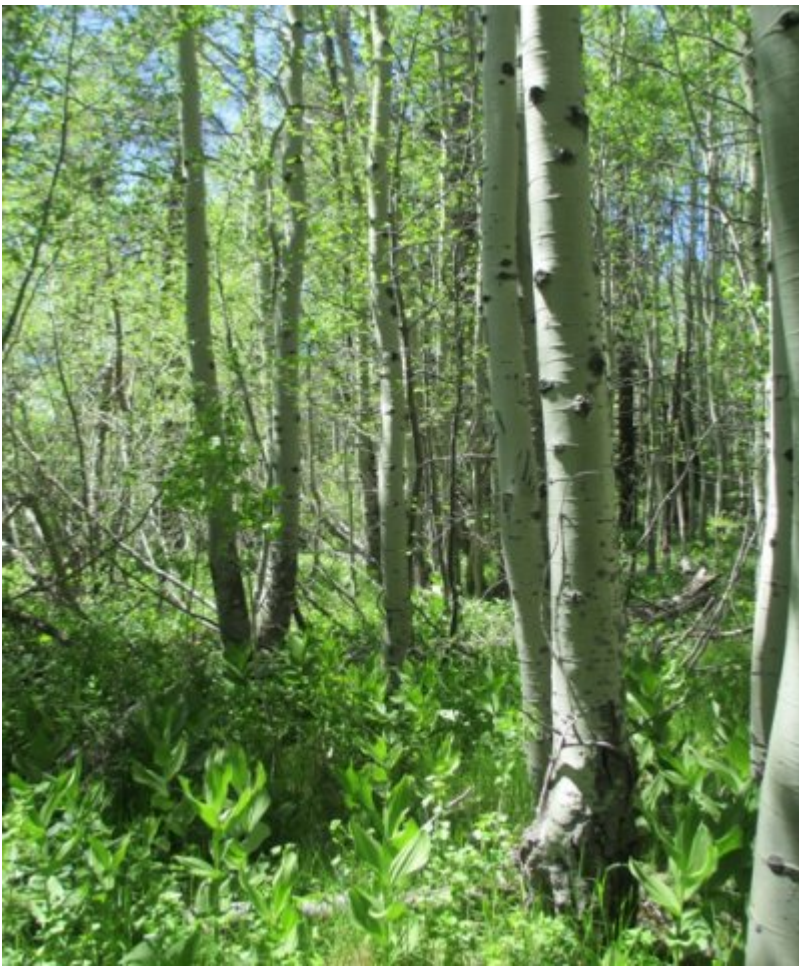
Figure 10. CC3

CC3, Drainageway, sideslopes

The dominant soil associated with this site is a higher order component, Aquic Xerorthents. It occurs on the side slopes of small drainageways. The soils have formed in a mix of alluvium and colluvium. The surface texture is sandy loam, with subsurface textures of sandy loam, coarse sandy loam, gravelly sandy loam, loamy coarse sand, and sandy loam. CC3 is associated with this site.
