## Ecological site R022BI215CA Frigid Gravelly Flood Plains

## R022BI215CA-Frigid Gravelly Flood Plains

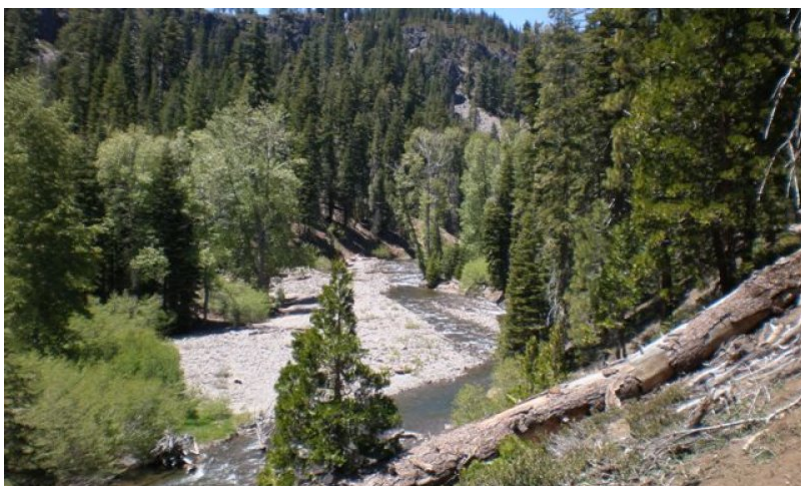
**Figure 4. Gravelly Flood Plains, Kings Creek**

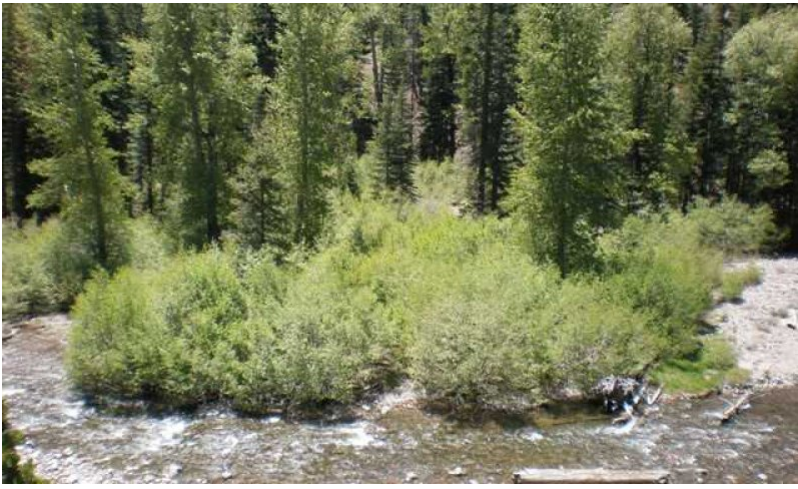
**Figure 5. Gravelly Flood Plains**
