Ecological site R034AA011UT **Riparian Complex Perennial Gravelly VIII/E4 (Northwest Territory Sedge)**

Ecological site concept

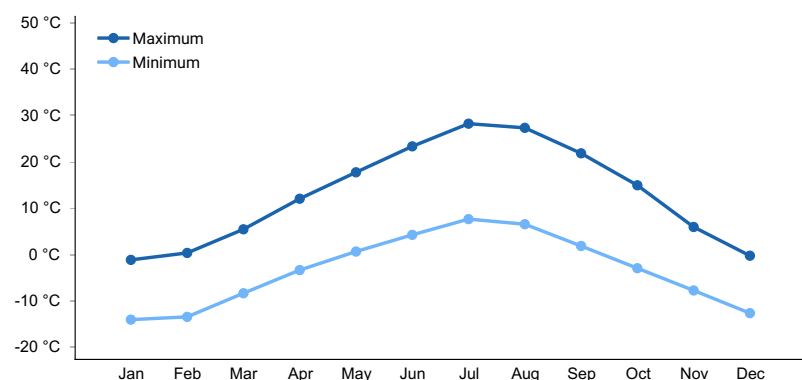
Figure 2. Monthly average minimum and maximum temperature

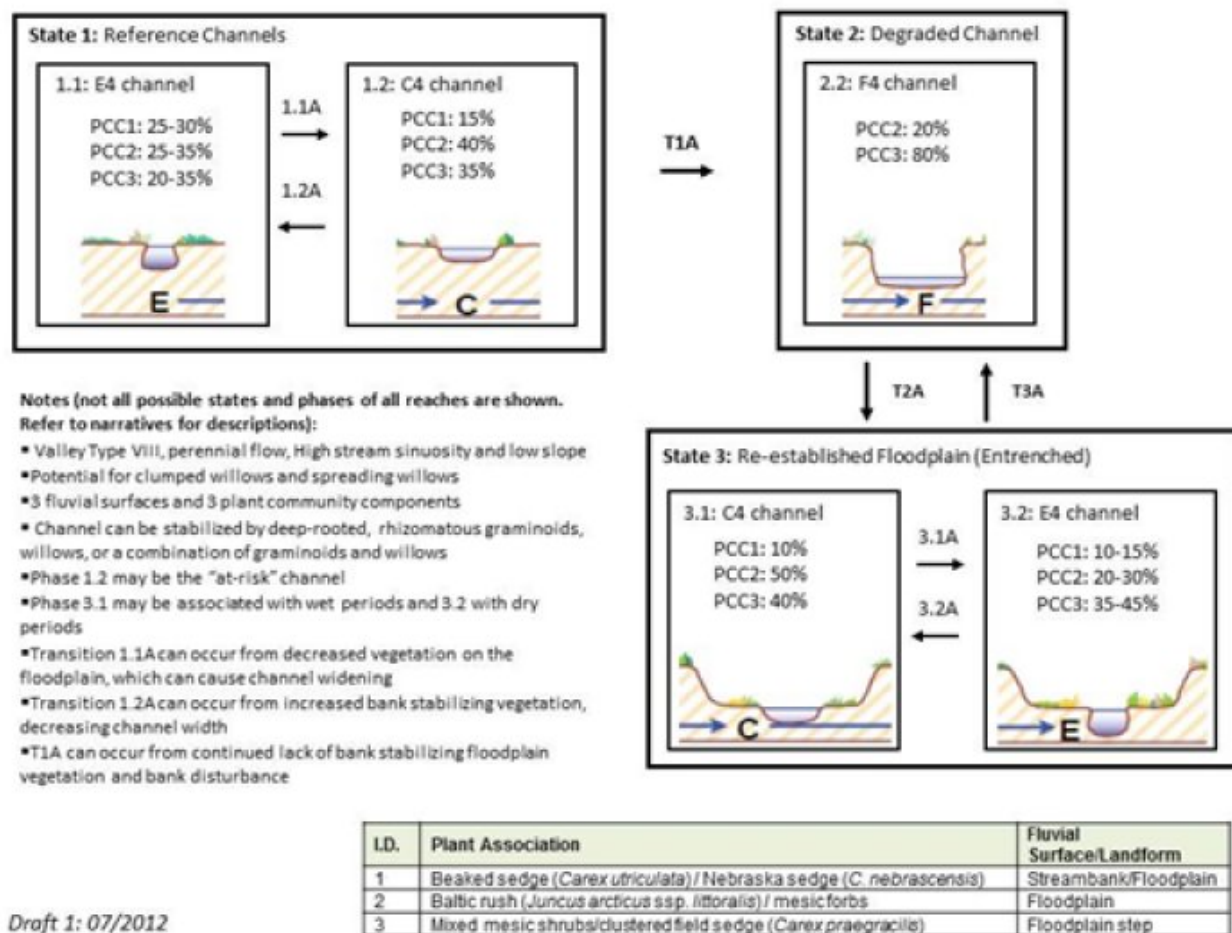
Figure 3. State and Transition Model R034AA011UT

State 1 Reference

The reference state for this site is a low gradient, meandering, very low width/depth stream channel with associated streambank, flood plain and flood-plain step landforms and plant community components. The stream channel typically meanders across the entire valley bottom, which effects the placement of each plant community. All plant communities can be present in this state.

Transition T1A

State 1 to 2

Change in vegetation on the banks to shallow rooted species, decrease in bank stability and bank sloughing causing a change in channel geometry to a wider shallower channel

Transition T2A

State 2 to 3

Vegetation re-establishment on streambanks and floodplain, rest from grazing pressure

Transition T3A

State 3 to 2

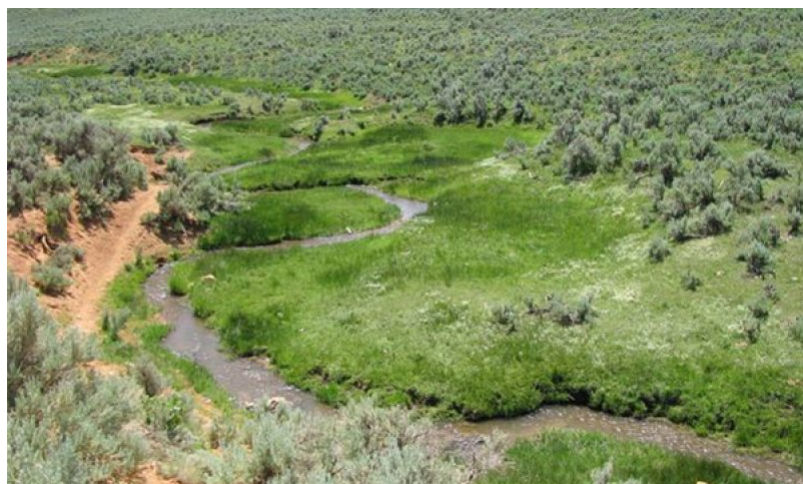
Figure 4. Site overview

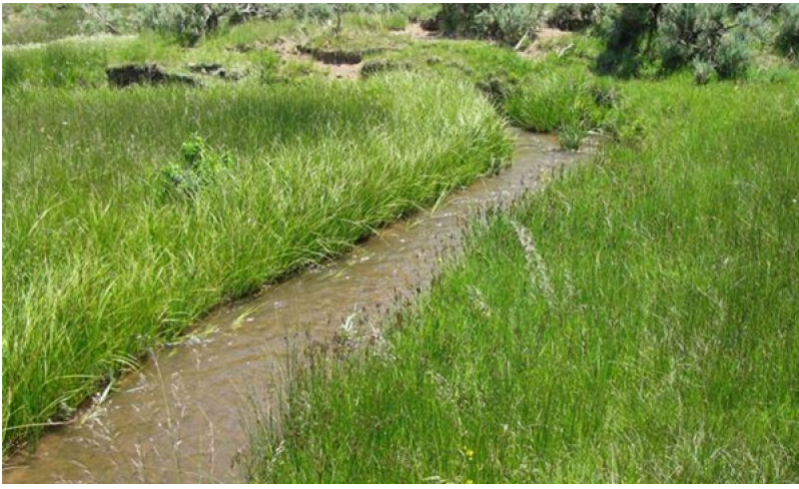
Figure 5. Streambank (PCC1) community

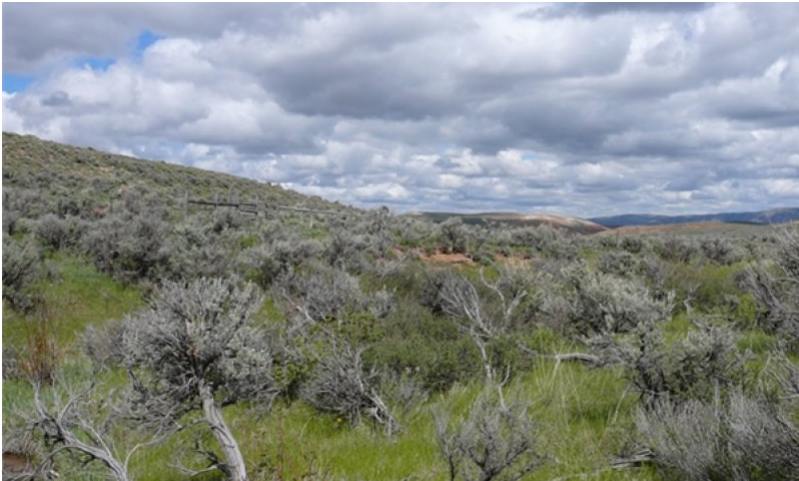
Figure 6. Flood-plain step plant community (PCC3)

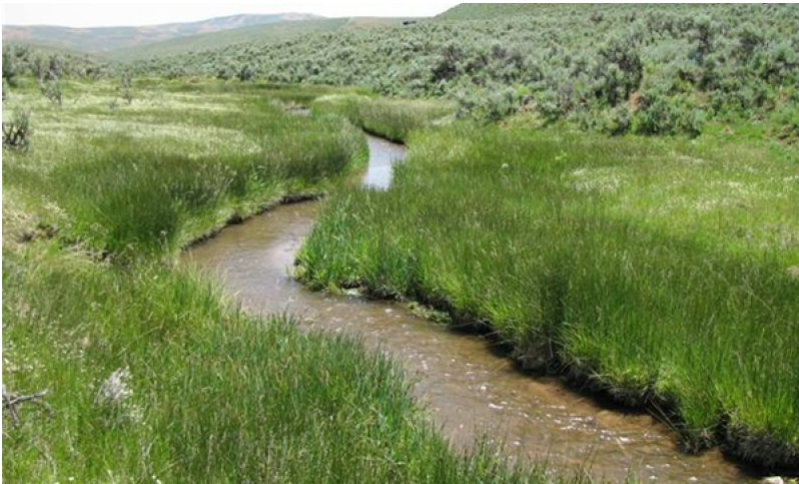
Figure 7. Streambank and flood plain plant communities

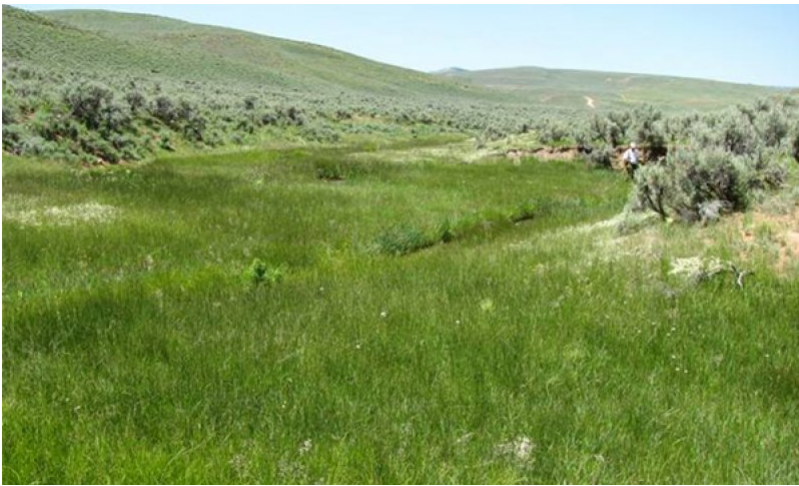
Figure 9. Graminoid dominated flood plain community

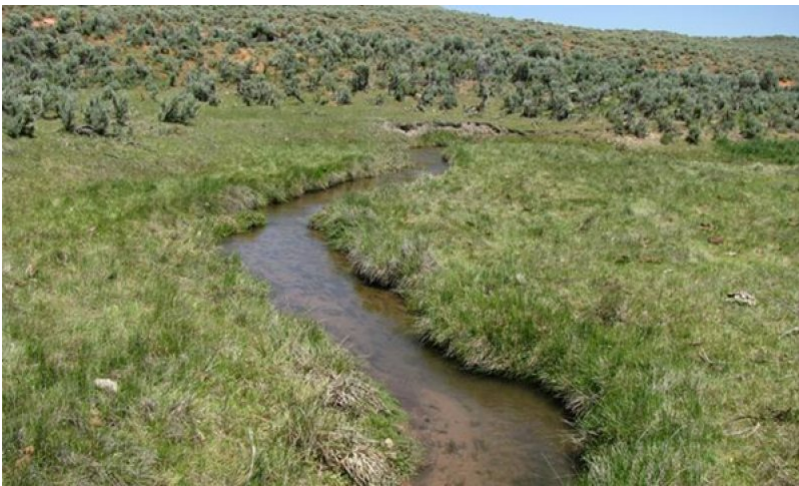
Figure 10. Grazing effects on plant community components

Observed grazing influence on this site has been attributed to bank sloughing and shrub decline (WICHE 75). Northwest Territory sedge is typically not found in areas with heavy grazing while Nebraska sedge appears to be more tolerant of grazing. These sedges have similar root structures and both provide bank stability. Surveys performed on this site in the 1970s indicate that shrubs were present, but provided low cover and were decadent. Lack of shrubs presently indicates that conditions for willow regeneration have not been present. Grazing impacts may also lead to a change in plant community composition. Kentucky bluegrass is a non-native grass often found within this site. This grass is shallow rooted and does not have the bank stability capacity of rhizomatous sedges. This shift in plant communities has an effect on stream bank stability. Riparian meadow communities dominated by sedges and rushes have a much greater root densities than grasses (Manning et al. 1989). So when these communities are degraded and lose the sedges and Kentucky bluegrass established, it decreases the stream bank stability (Manning et al. 1989).

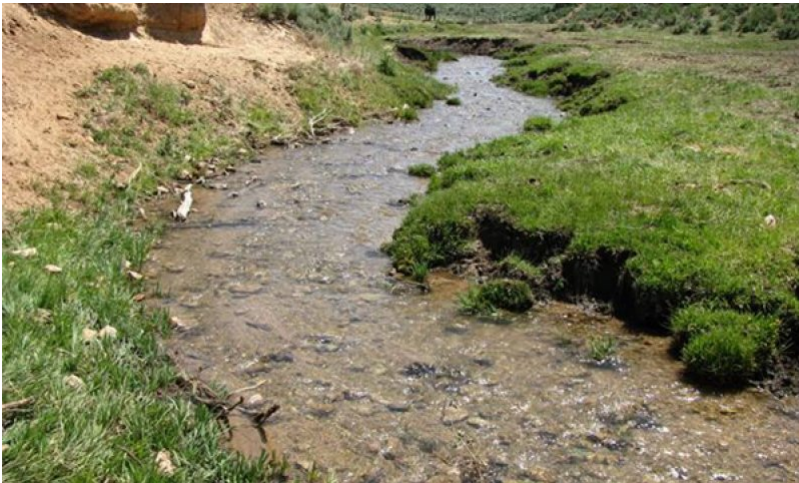
Figure 15. Bank sloughing and channel widening
