Ecological site R034AA011UT Riparian Complex Perennial Gravelly VIII/E4 (Northwest Territory Sedge)

Ecological site concept

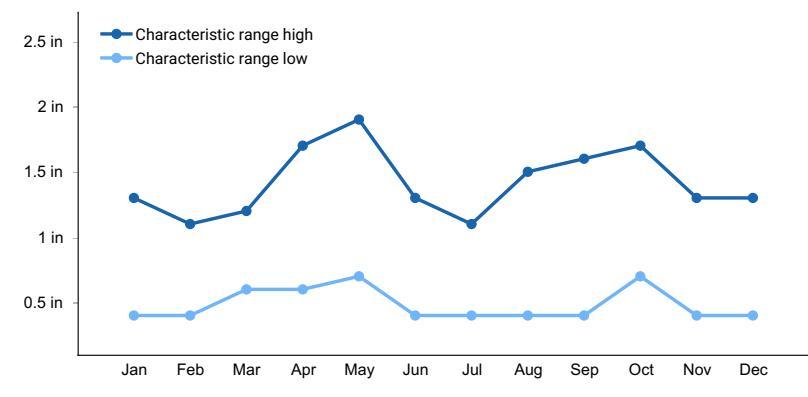
Figure 1. Monthly precipitation range

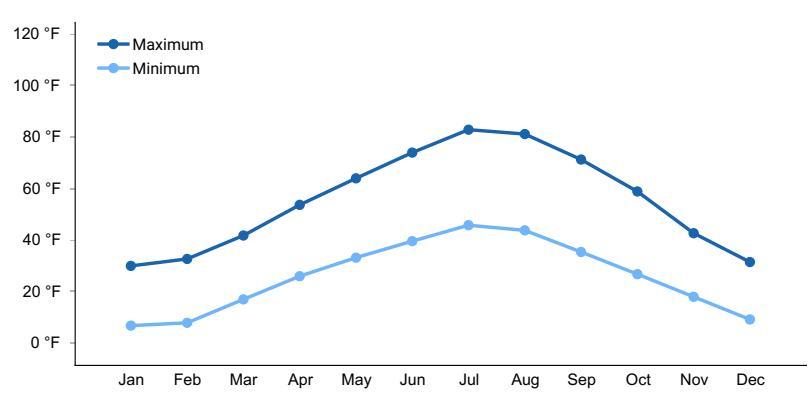
Figure 2. Monthly average minimum and maximum temperature

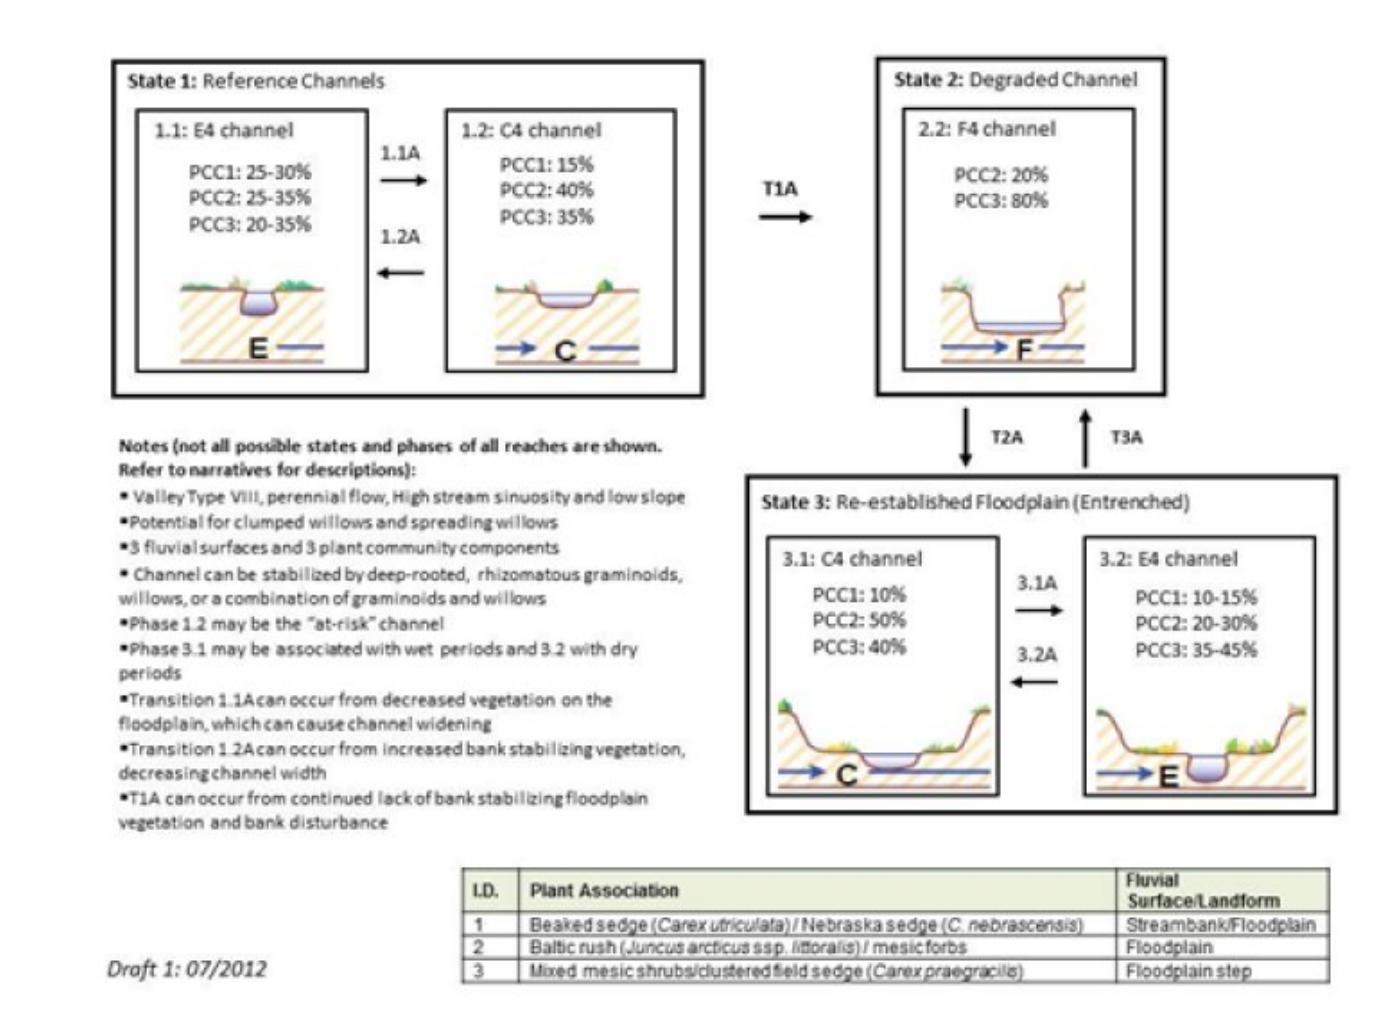
Figure 3. State and Transition Model R034AA011UT

State 1 Reference

The reference state for this site is a low gradient, meandering, very low width/depth stream channel with associated streambank, flood plain and flood-plain step landforms and plant community components. The stream channel typically meanders across the entire valley bottom, which effects the placement of each plant community. All plant communities can be present in this state.

Transition T1A State 1 to 2

Change in vegetation on the banks to shallow rooted species, decrease in bank stability and bank sloughing causing a change in channel geometry to a wider shallower channel

Transition T2A State 2 to 3

Vegetation re-establishment on streambanks and floodplain, rest from grazing pressure

Transition T3A State 3 to 2

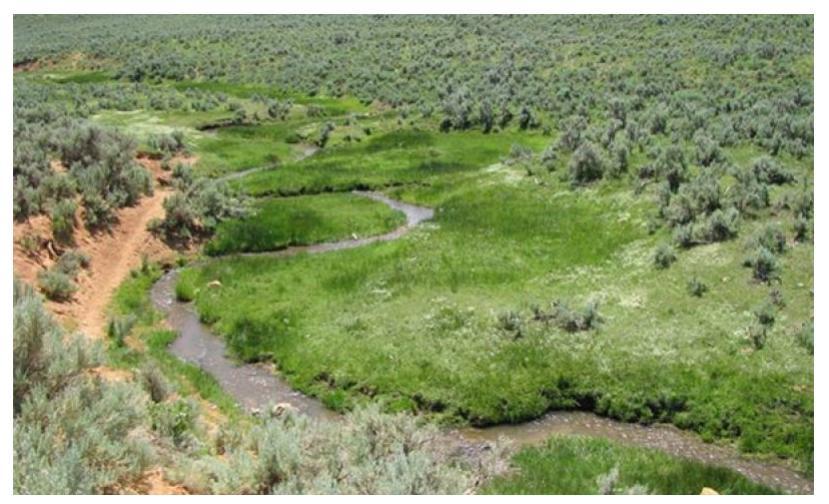
Figure 4. Site overview

This phase has a narrow and deep meandering channel with well-developed vegetation on the streambanks, predominantly composed of sedges and rushes. The flood plain receives regular flooding from snowmelt in the spring. All plant community components may be present in this phase.

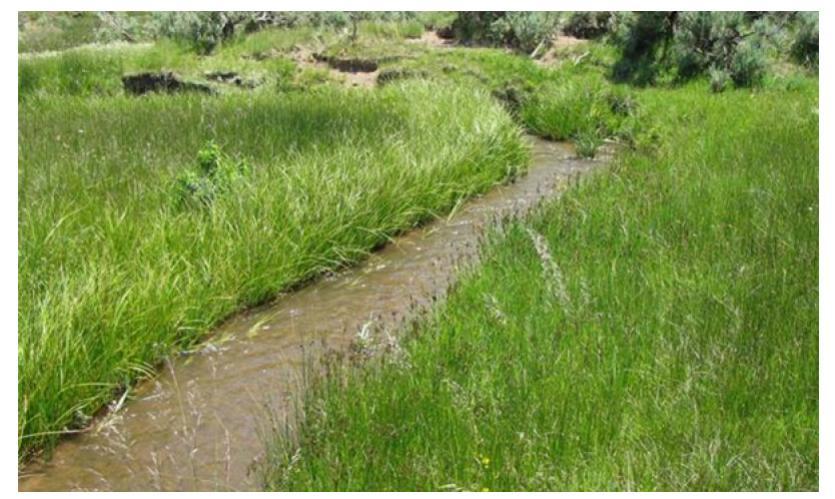
Figure 5. Streambank (PCC1) community

Northwest Territory sedge is found closest to the stream channel or in low swales in the floodplain where the water table is high. Northwest Territory sedge and Nebraska sedge are able to tolerate inundation for extended periods of time, which is why they are found in areas with high water table. Their root structure also allows them to withstand flood events. The rhizomatous nature of these sedges allow them to dominate areas where they are found, leading to low diversity (Hoag & Zierke 1998). Willows can come into this community under the correct conditions. Willows require fresh wet sediment for germination and this occurs at the site after high flow deposits sediment on the floodplain. Willow typically occurs on this site further away from the channel, but still within the streambank/floodplain community.

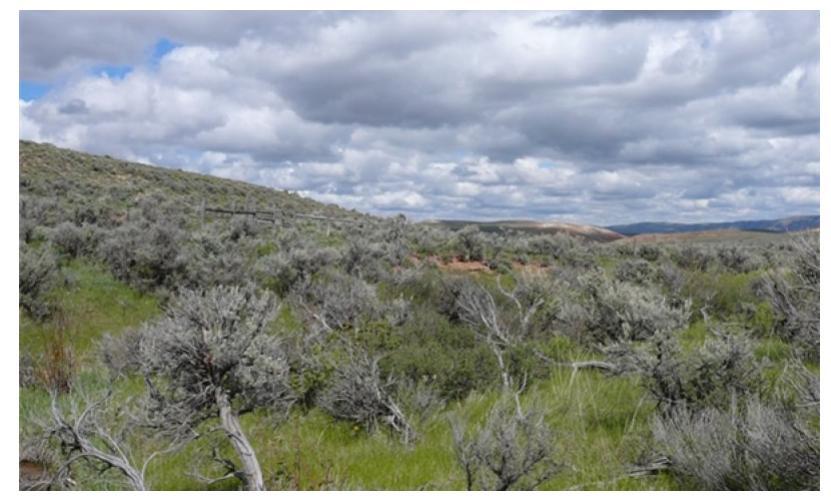
Figure 6. Flood-plain step plant community (PCC3)

Plant community component 3 is dominated by graminoids and shrubs, specifically currant, rose, basin big sagebrush, and shrubby cinquefoil. Shrubby cinquefoil is the dominant shrub. This community is typically found on stable fluvial surfaces with soil development (Padgett et al. 1989). This community is composed of species that are shallow rooted and will provide little streambank stability if the stream cuts into this community (Padgett et al. 1989).

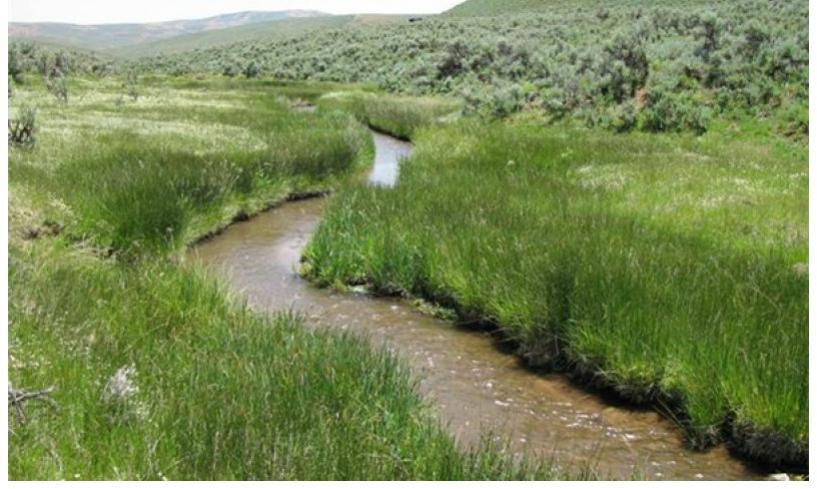
Figure 7. Streambank and flood plain plant communities

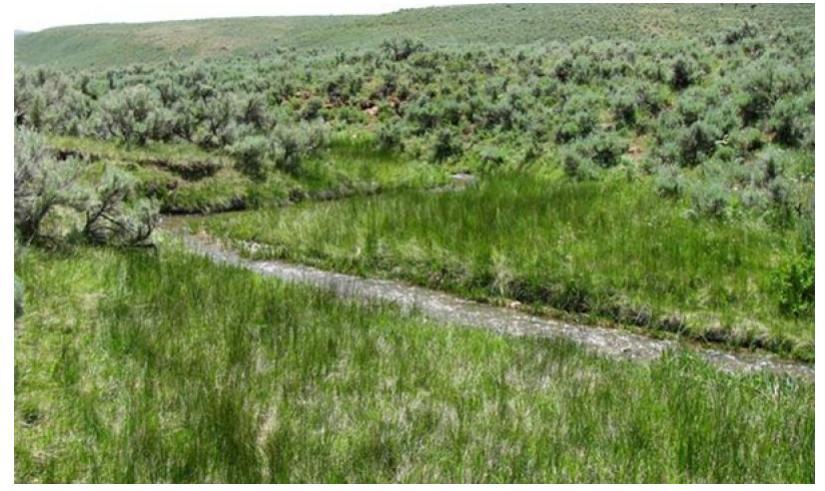
Figure 8. Flood plain plant communities with sagebrush on hi

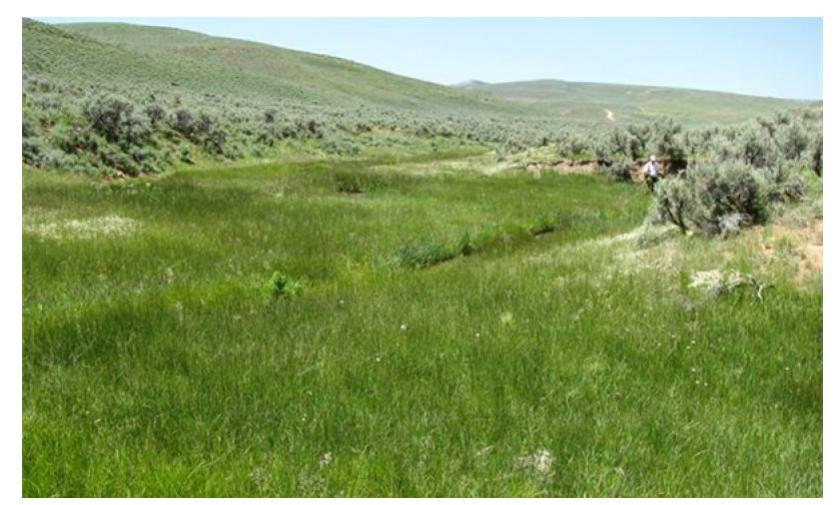
Figure 9. Graminoid dominated flood plain community

Plant community component 2 is drier than plant community component 1 and is further from the stream and has a deeper water table. The community is composed of various graminoids and forbs, particularly Baltic rush and in one location tufted hair grass.

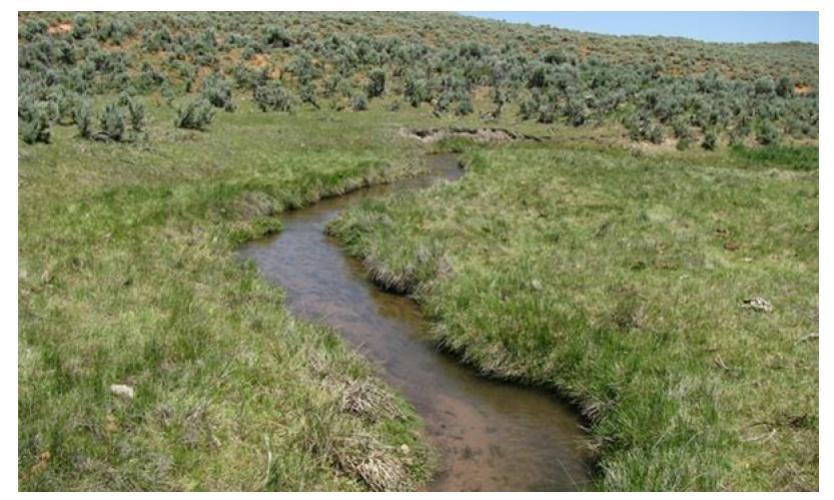
Figure 10. Grazing effects on plant community components

Observed grazing influence on this site has been attributed to bank sloughing and shrub decline (WICHE 75). Northwest Territory sedge is typically not found in areas with heavy grazing while Nebraska sedge appears to be more tolerant of grazing. These sedges have similar root structures and both provide bank stability. Surveys performed on this site in the 1970s indicate that shrubs were present, but provided low cover and were decadent. Lack of shrubs presently indicates that conditions for willow regeneration have not been present. Grazing impacts may also lead to a change in plant community composition. Kentucky bluegrass is a non-native grass often found within this site. This grass is shallow rooted and does not have the bank stability capacity of rhizomatous sedges. This shift in plant communities has an effect on stream bank stability. Riparian meadow communities dominated by sedges and rushes have a much greater root densities than grasses (Manning et al. 1989). So when these communities are degraded and lose the sedges and Kentucky bluegrass established, it decreases the stream bank stability (Manning et al. 1989).

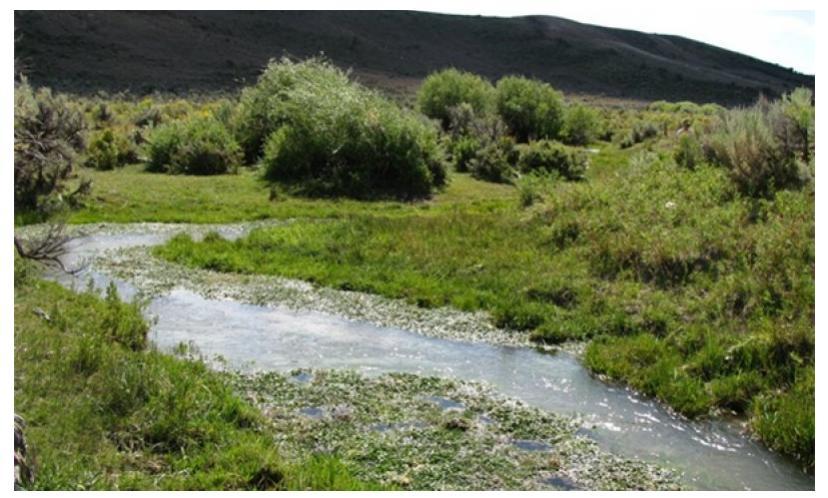
Figure 12. Channel narrowing with early colonizing species, C

This phase has a slightly wider channel and more deposition and erosion occurring around the meander bends. This phase may occur after large floods or may occur after grazing. All plant community components may be present in this phase.

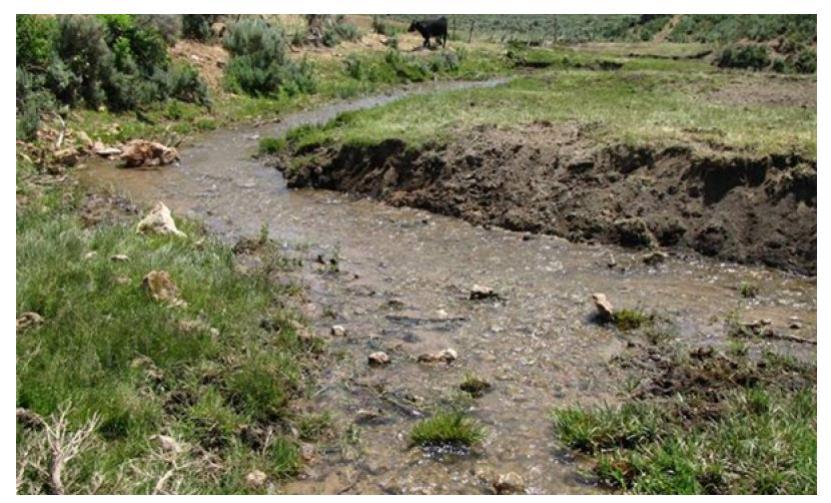
Figure 13. Eroded banks, loss of streambank plant community (

This state is characterized by a shift in the composition of plant community components due to season long grazing pressure. The sedges and willow typically found on the streambanks are particularly palatable to livestock and can be grazed at a level that weakens the plant eventually leading to loss from the site (i.e. Northwest Territory sedge). Kentucky bluegrass often replaces these sedges along the streambank (see Ecological Dynamics section). Bank sloughing is prevalent.

This phase results from excessive lateral erosion creating a wide, shallow stream with unstable streambanks. PCC 1 is largely lost in this phase.

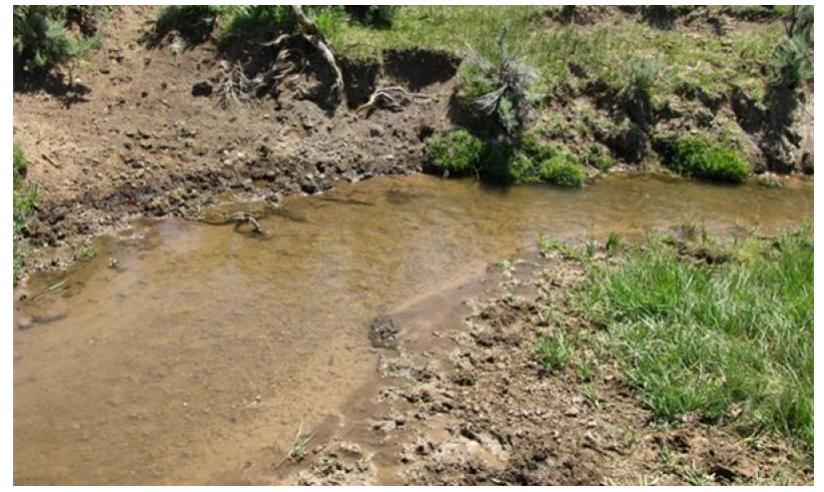
Figure 14. Bank erosion and channel widening

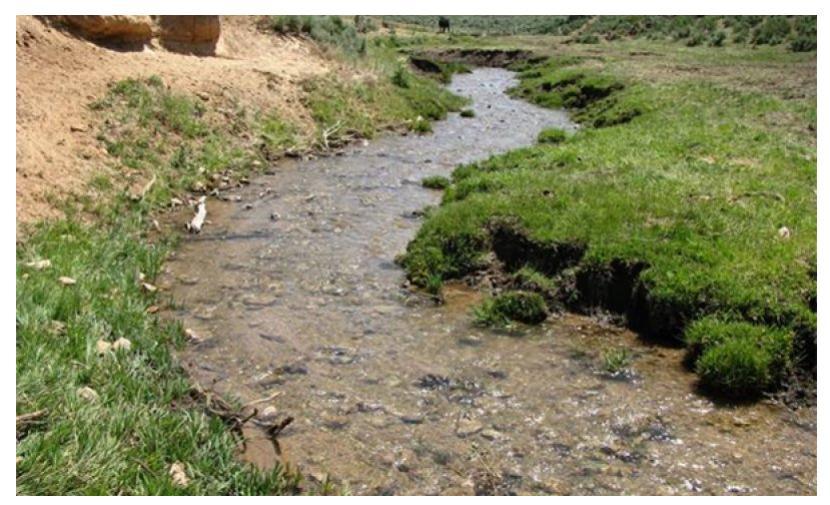
Figure 15. Bank sloughing and channel widening

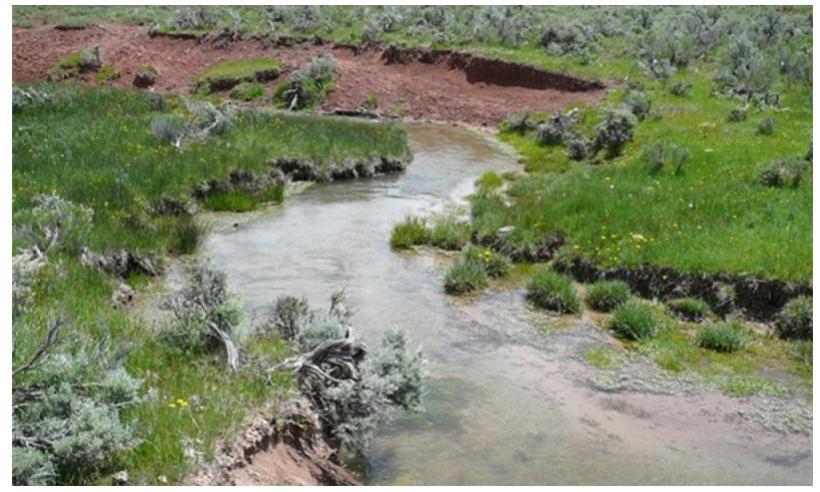
Figure 16. Channel widening

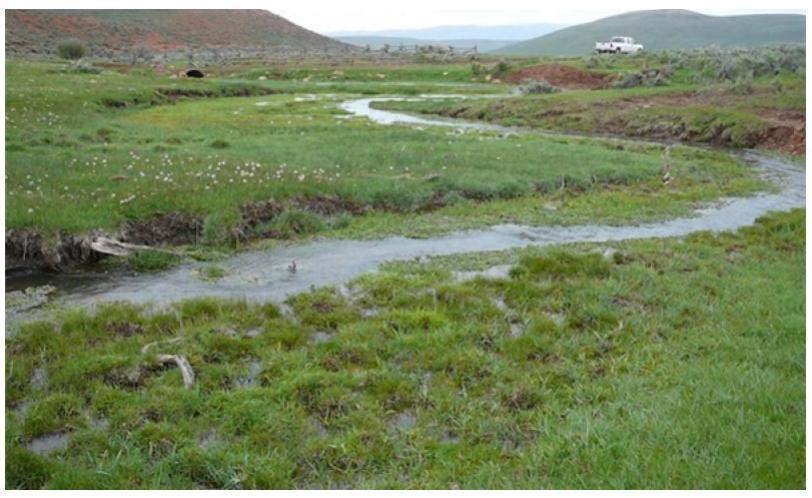
Figure 17. Early colonizing species begining to establish on

This phase functions similarly to 1.2 at a lower elevation with a narrower floodplain and plant community components.

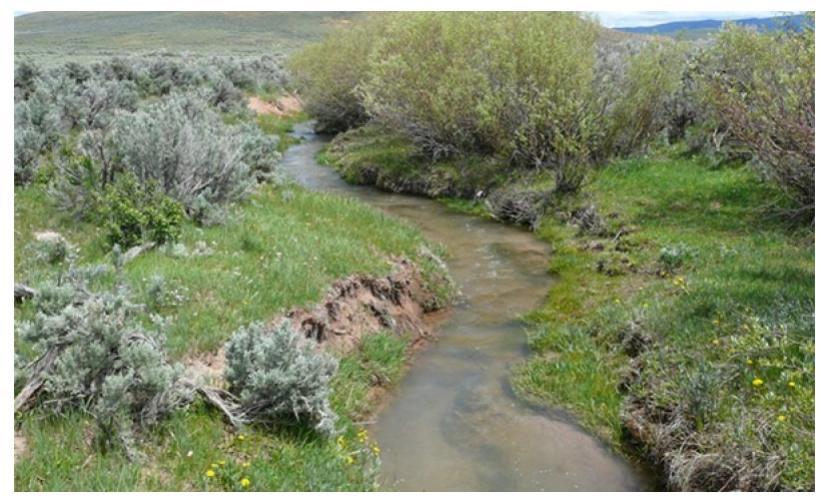
Figure 18. Channel narrowing after bank sloughing, stream ban

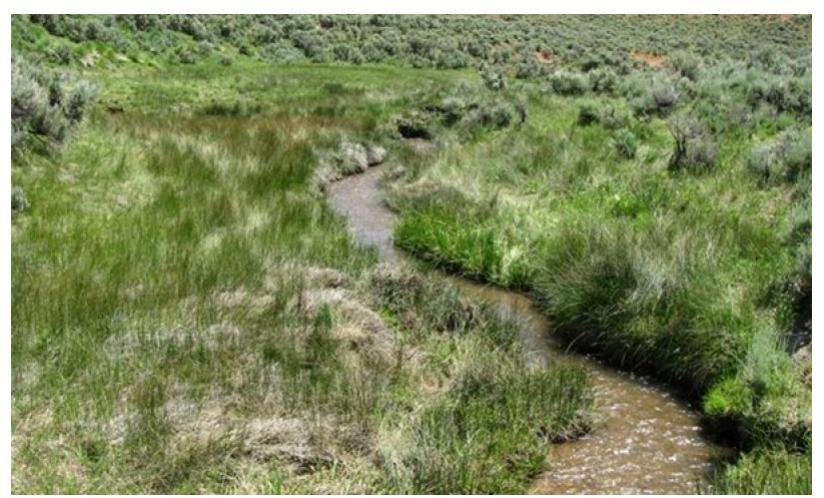
Figure 19. Recovering narrow channel

This phase functions similarly to 1.1 at a lower elevation with a narrower floodplain and plant community components.

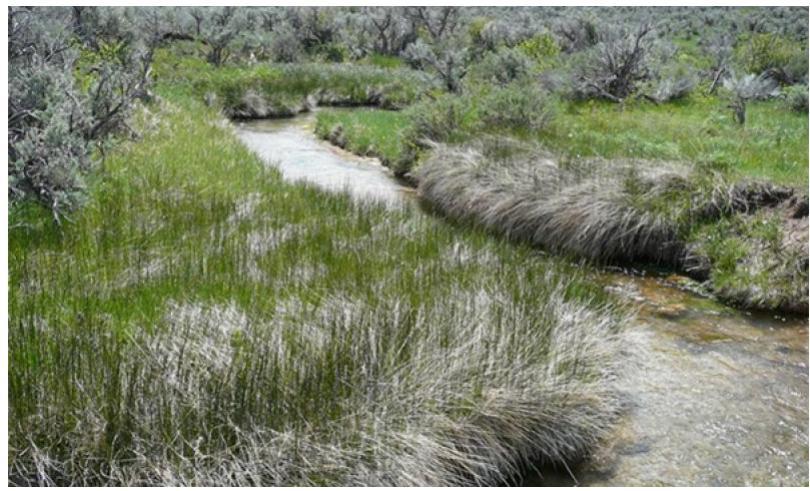
Figure 20. Streambank community establishing
